MEMORANDUM

Date:	December 4, 2008	TG:	08296.00
To:	Steve Clark, City of Burien		
From:	Dan McKinney Jr., Transpo Group Scott Lee, Transpo Group		
Subject:	Goat Hill Speed Study

This memorandum summarizes the results of a speed study performed in the Goat Hill Neighborhood of Burien. Specifically, speeds and traffic volumes were monitored along the corridor of SW 130 Street/Shorewood Drive corridor between 14th Avenue SW and Shorewood Place at 6 locations. The study was performed to determine if a speeding problem exists within the neighborhood and recommend measures to help reduce speeds as appropriate. This memorandum will discuss the following:

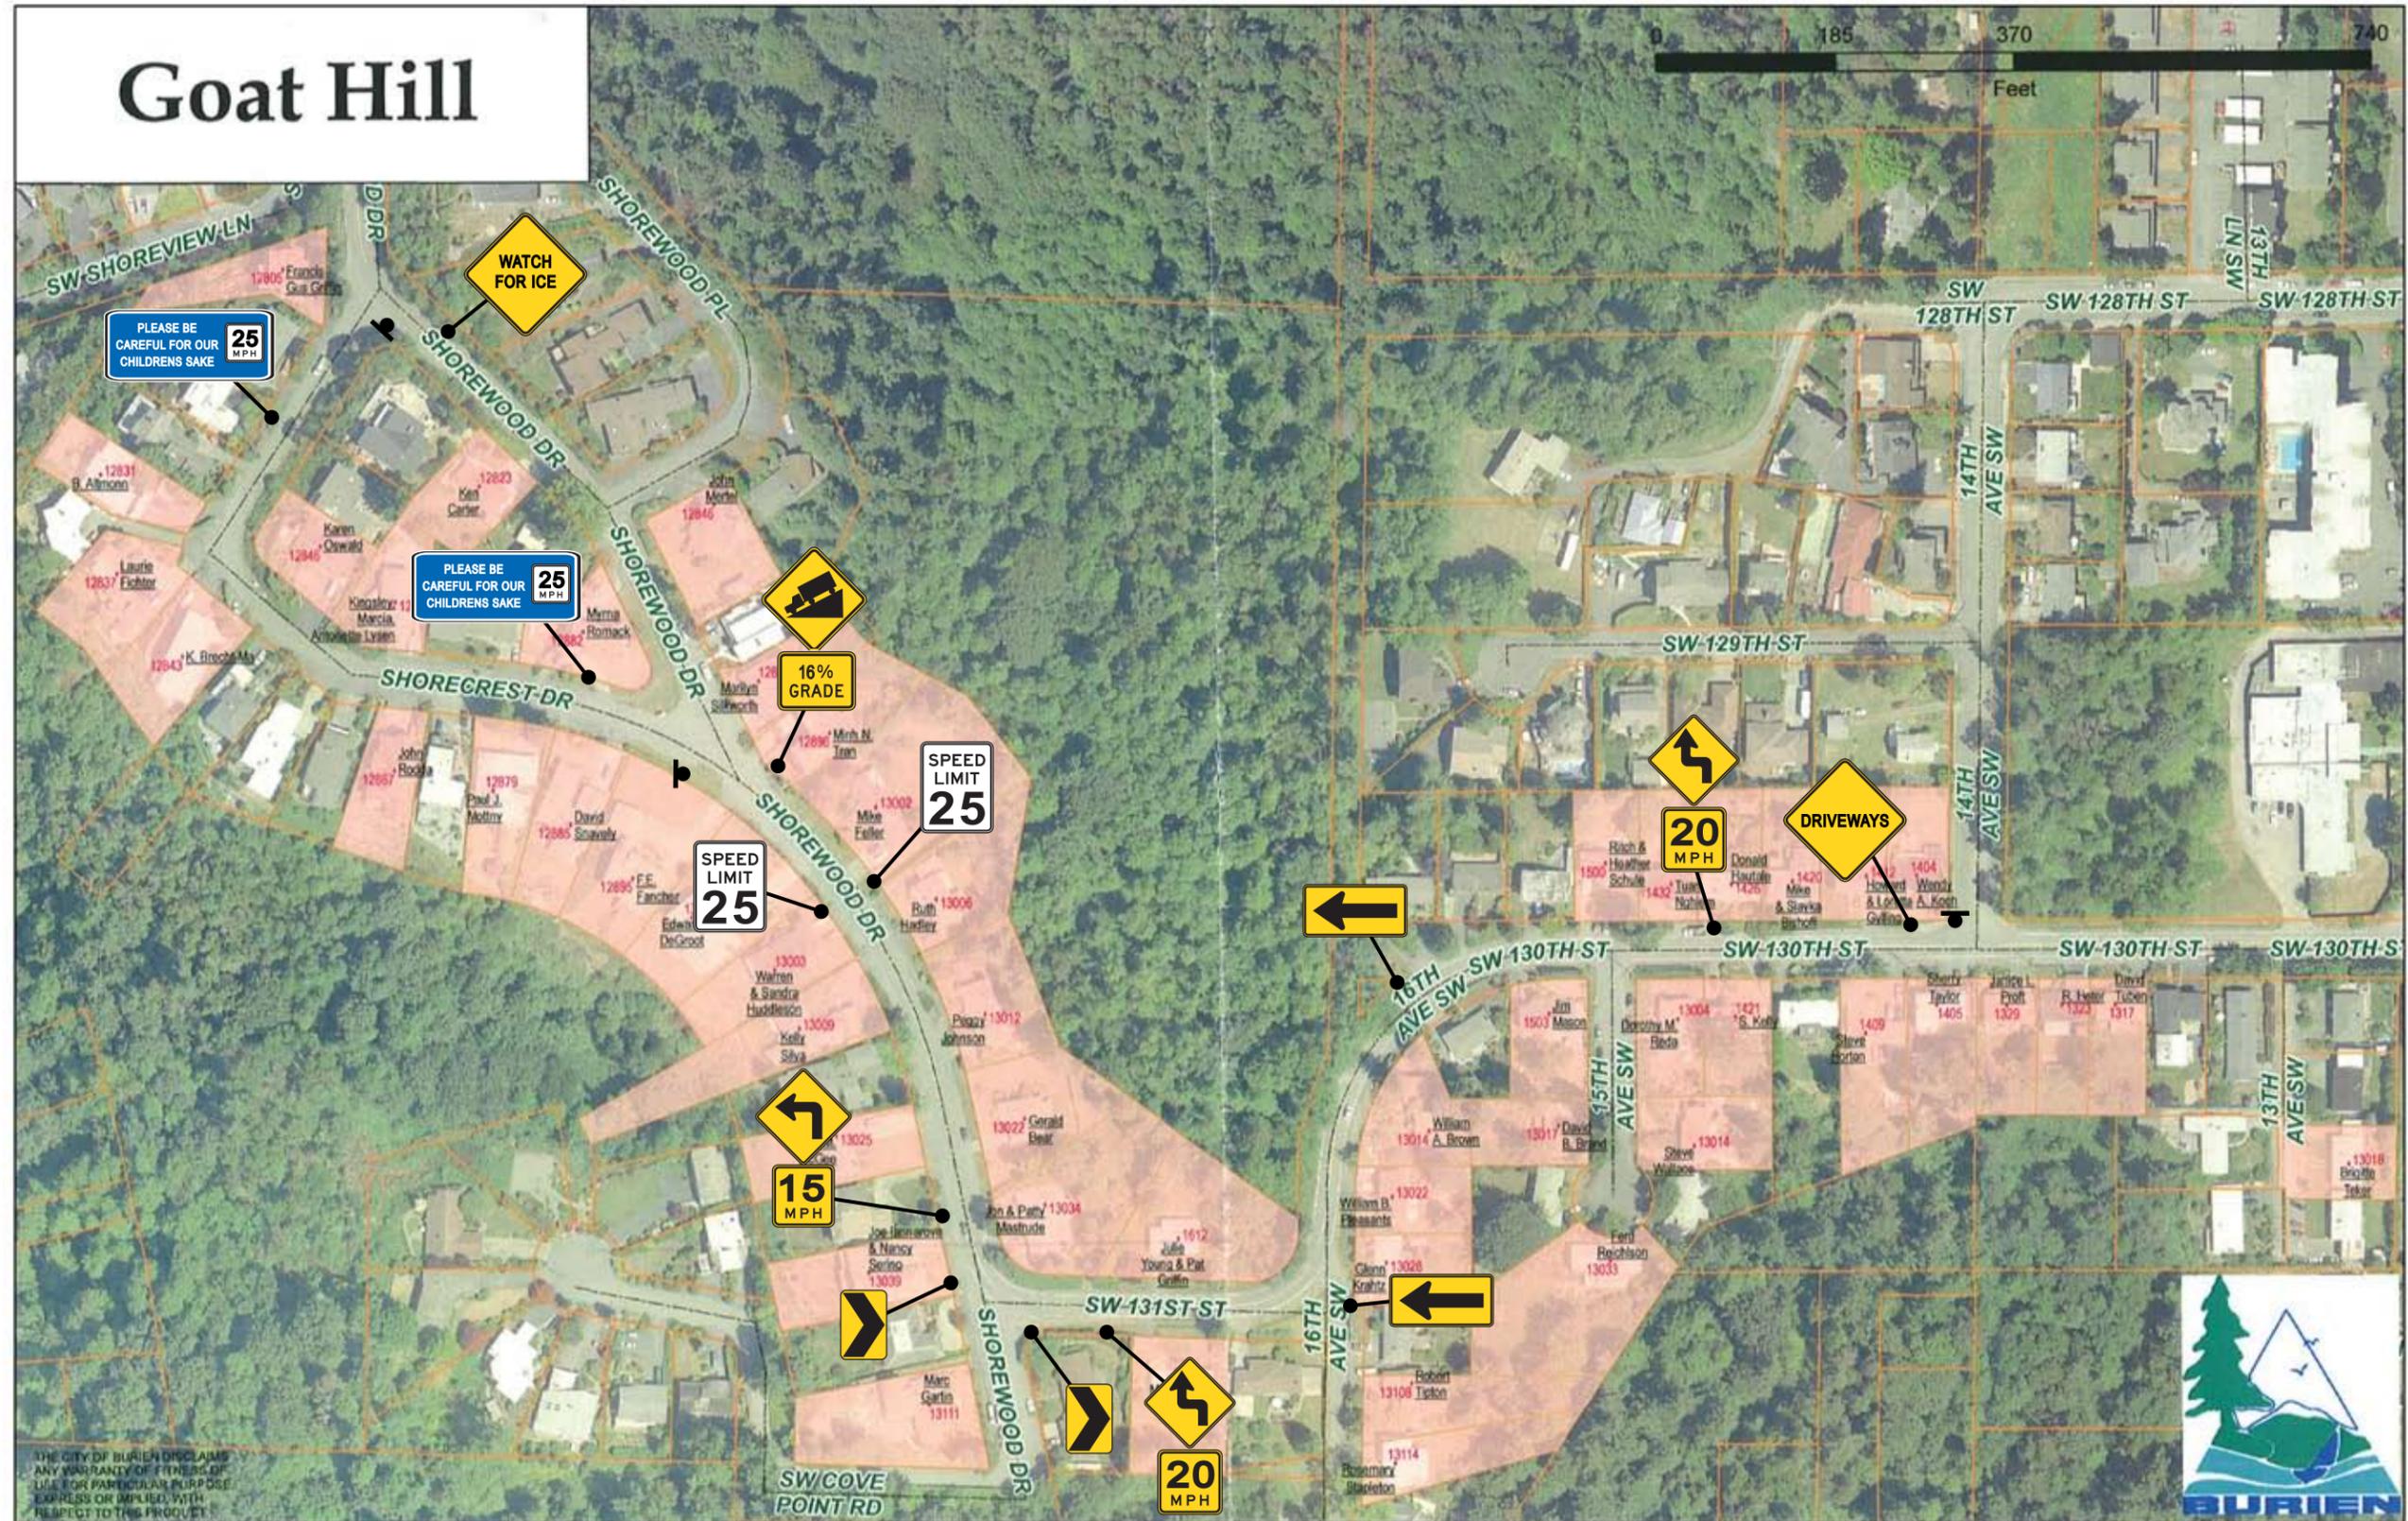
Speed Advisory Sign Locations

Burien-Goat Hill Speed Study

The roadways providing access to the Goat Hill Neighborhood serve residential traffic via Ambaum Boulevard SW and are not considered “cut through” routes for general traffic. The study roadways consist of two lanes and serve as residential collector with direct access to numerous driveways. Currently the posted speed limit along the study roadways within the Goat Hill Neighborhood is 25 mph with 15 mph and 20 mph advisory speeds around some of the sharper curves. For general reference, Attachment 1 illustrates the approximate location and type of traffic advisory signs within the study area.

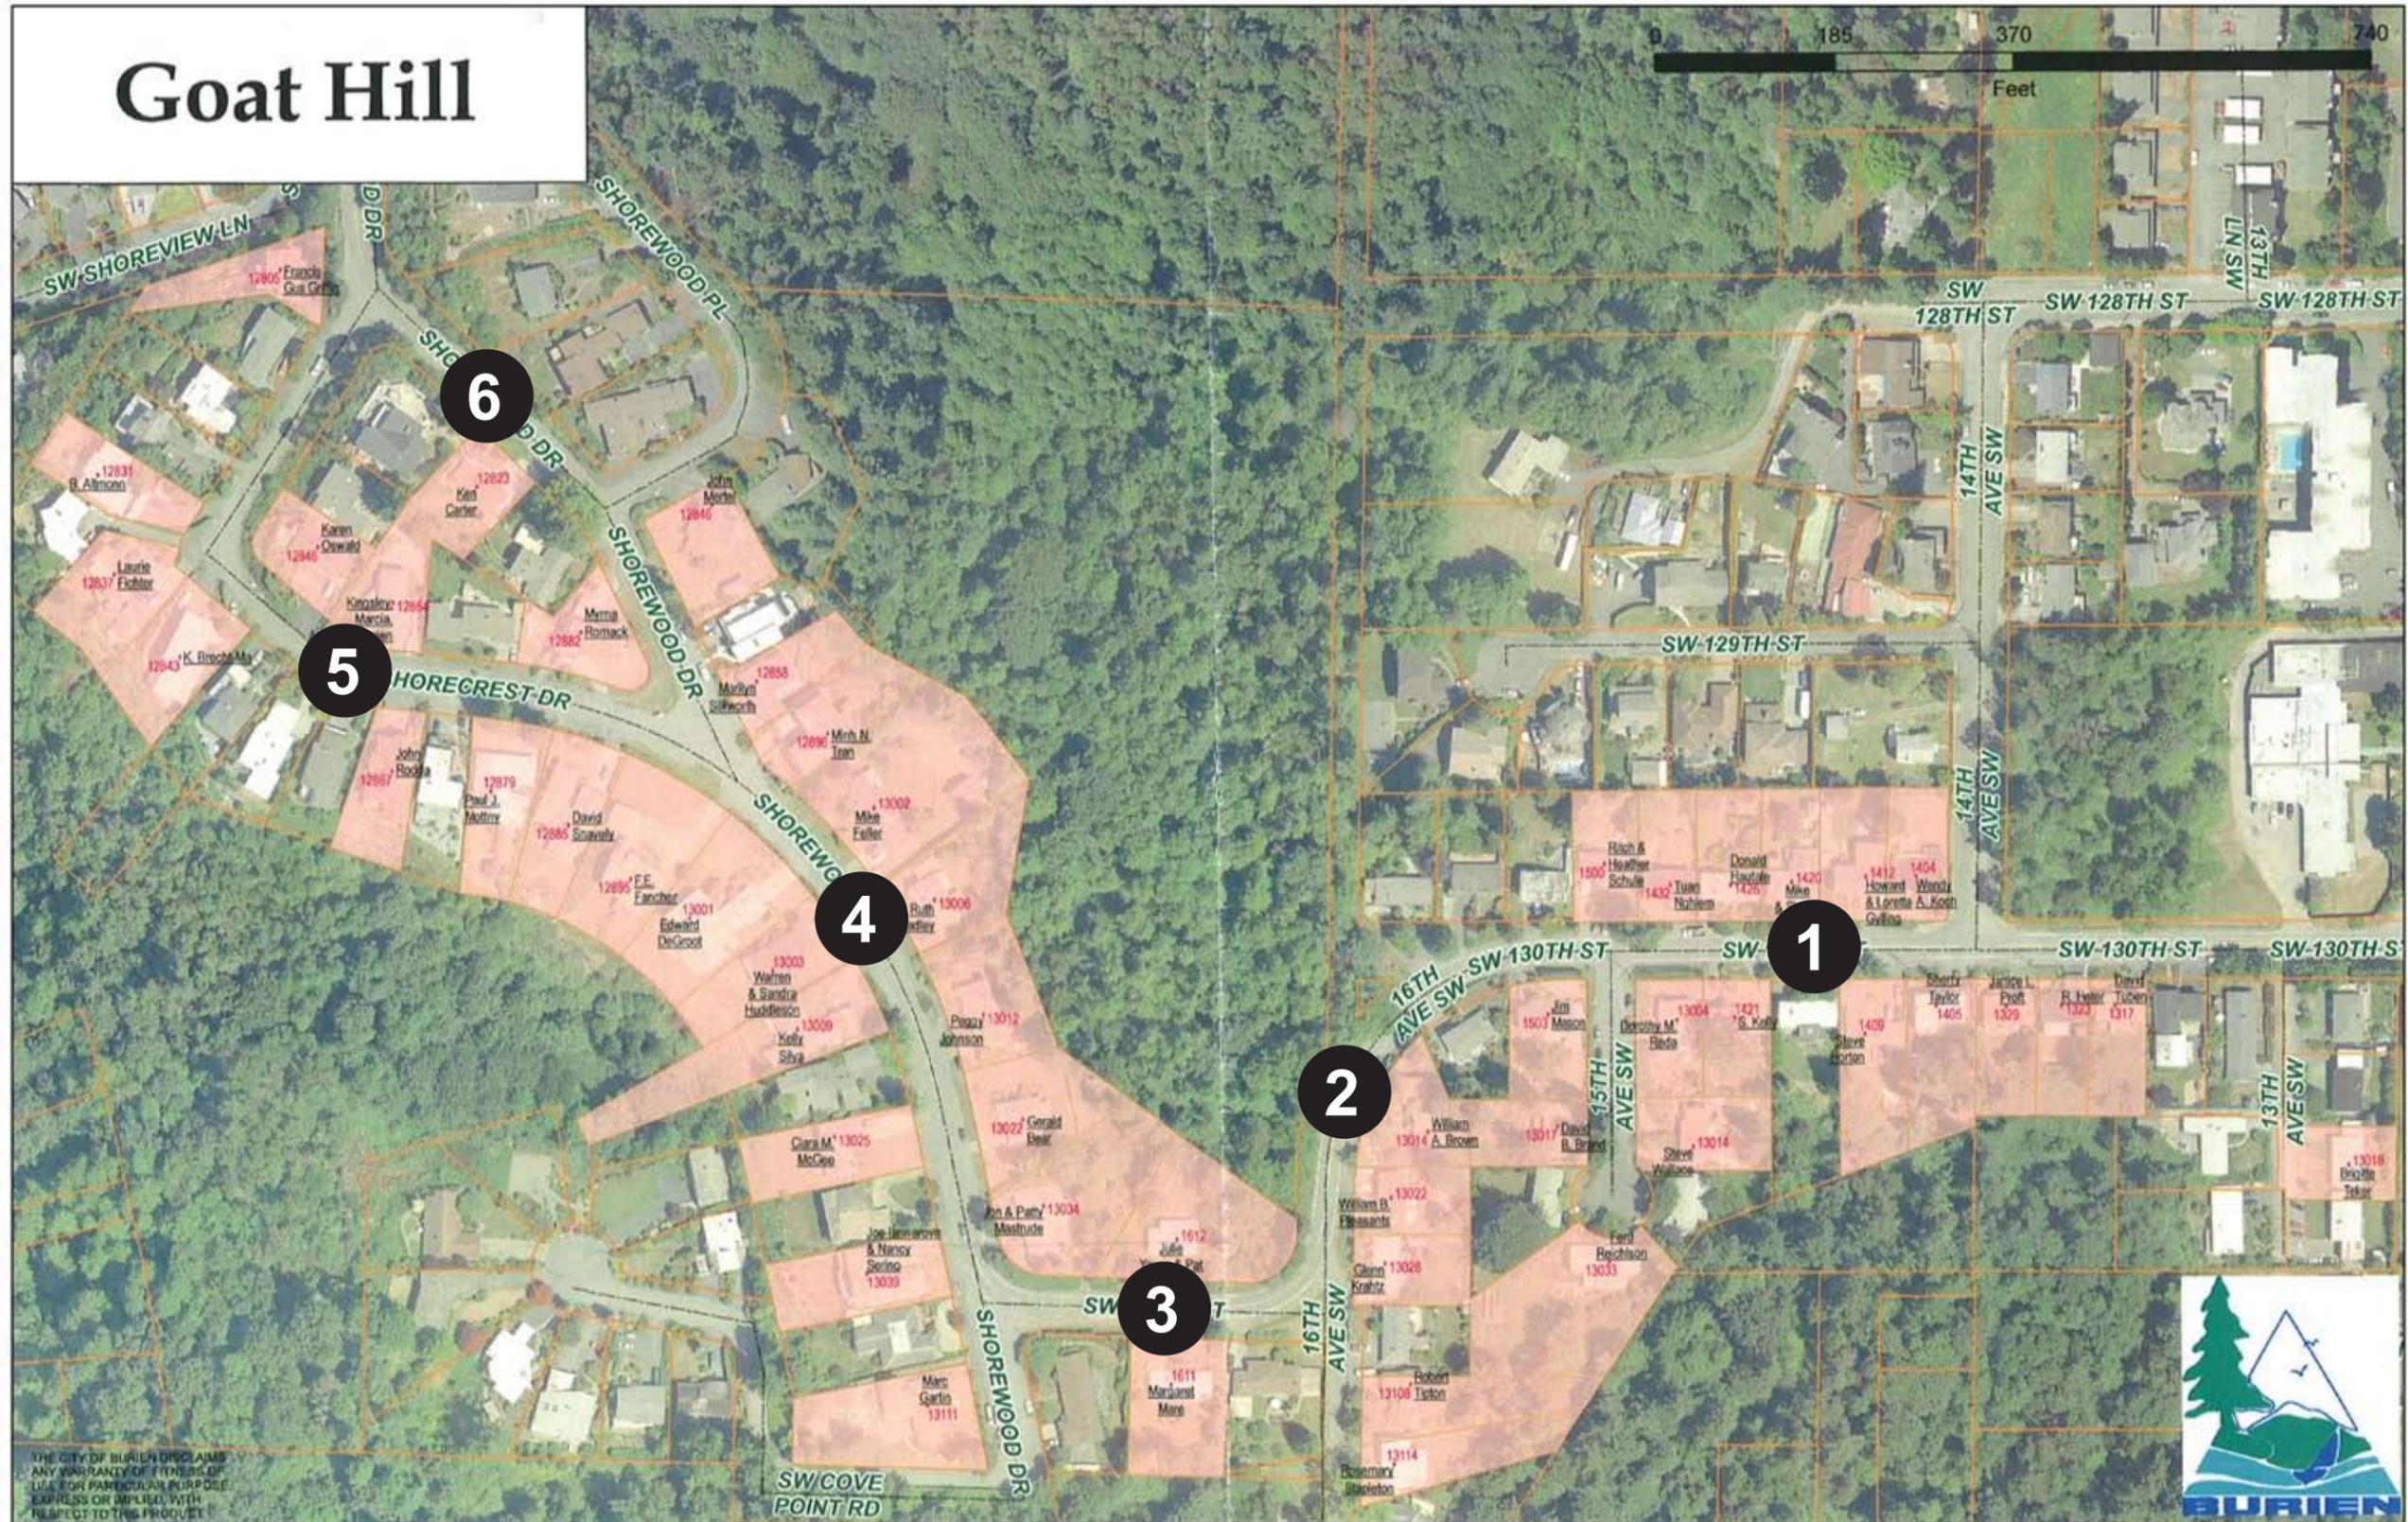
Note: Speed study locations are approximate.

Speed Study Locations

Speed data and traffic volumes were collected at six locations along the corridor for seven consecutive days in October 2008. The six locations studied are listed below and illustrated in Attachment 2.
